Subj: CONSTRUCTION CONTRACT 89-B-2611, TEMPORARY FUEL FARM

CAMP LEJEUNE FUEL FARM

Doc No: OLEJ-00231-1.92-8/9/84
CONDITION SURVEY
POL FACILITIES
CAMP LEJEUNE, NORTH CAROLINA
27 June 1980

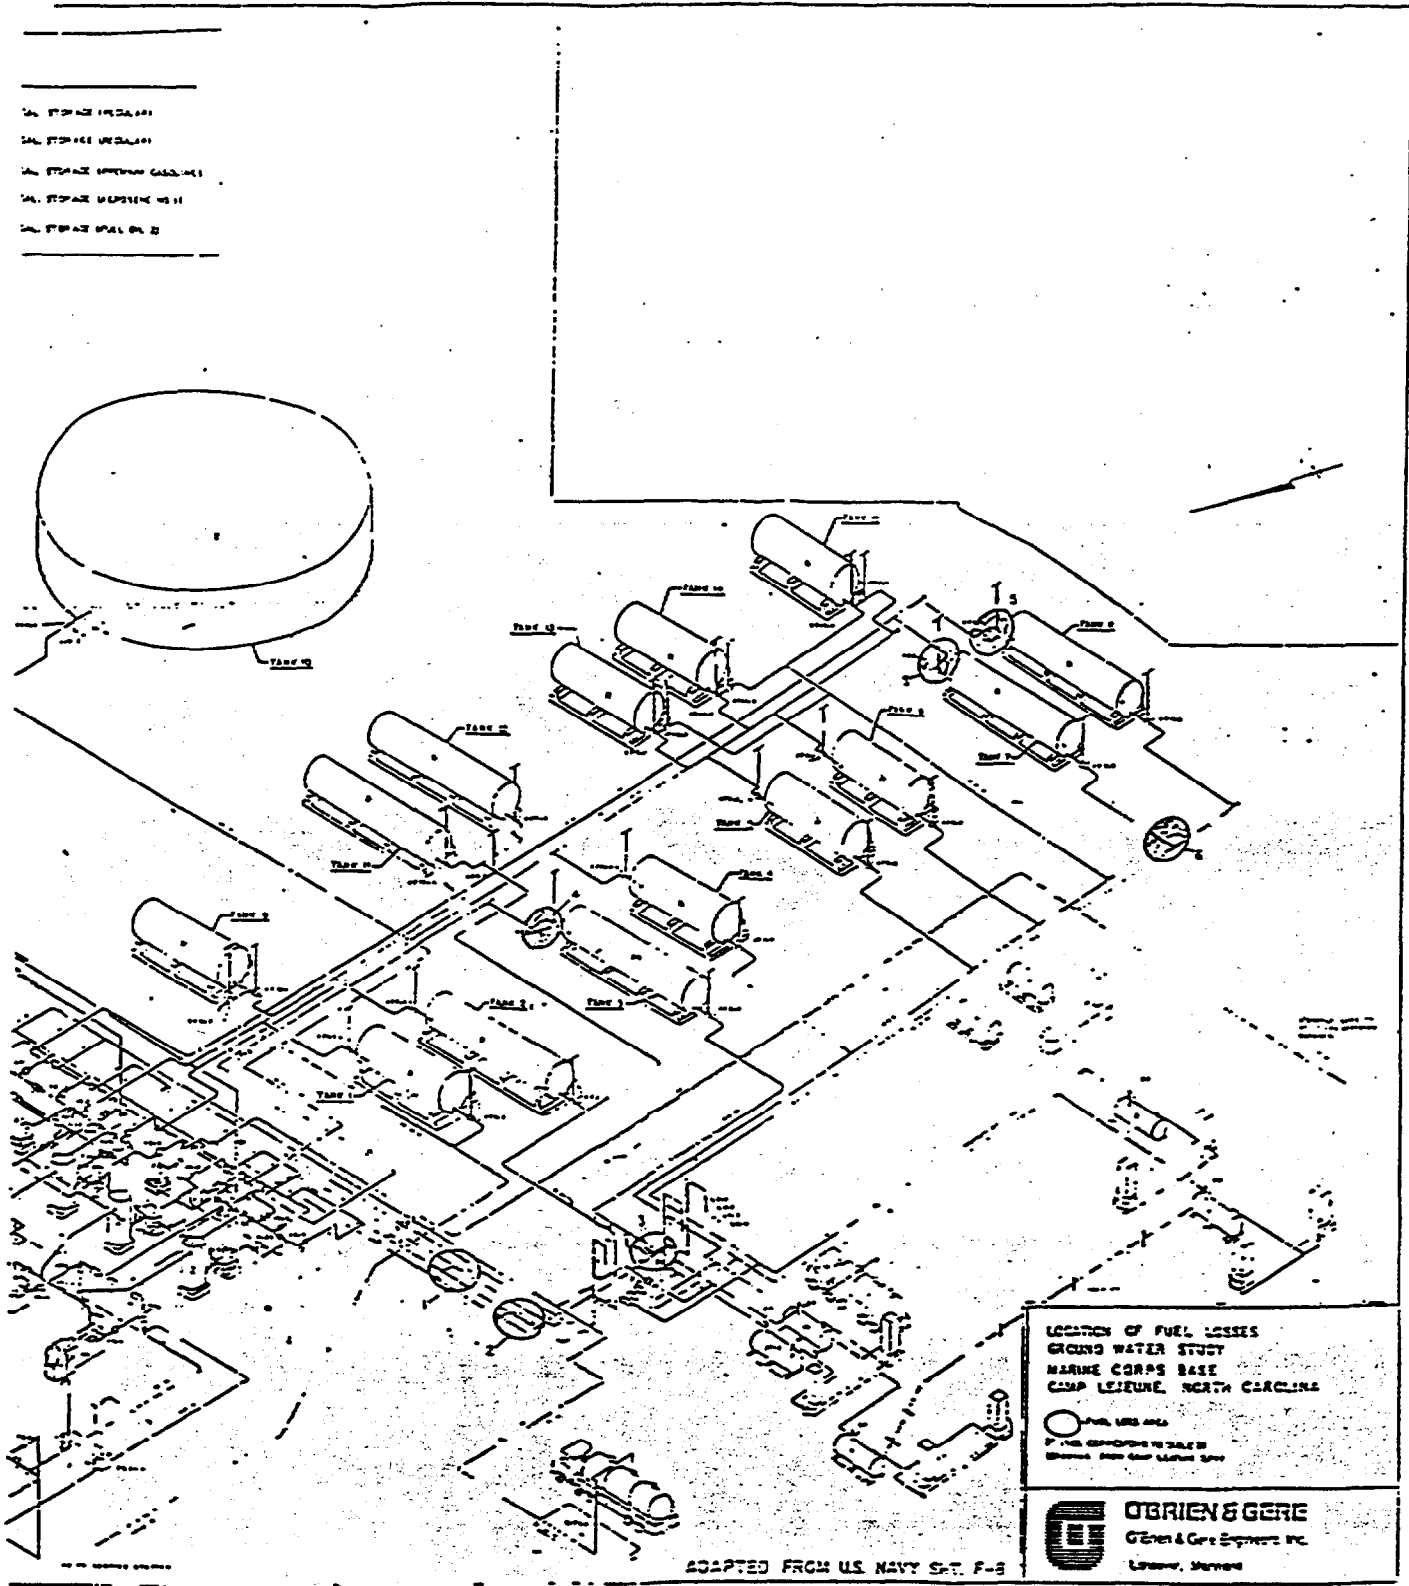
FIGURE 3

LOCATION OF FUEL LOSSES
GROUND WATER STUDY
MARINE CORPS BASE
CAMP LEJEUNE, NORTH CAROLINA

○ FUEL LOSS AREA
○ FUEL LOSS MONITORING POINT

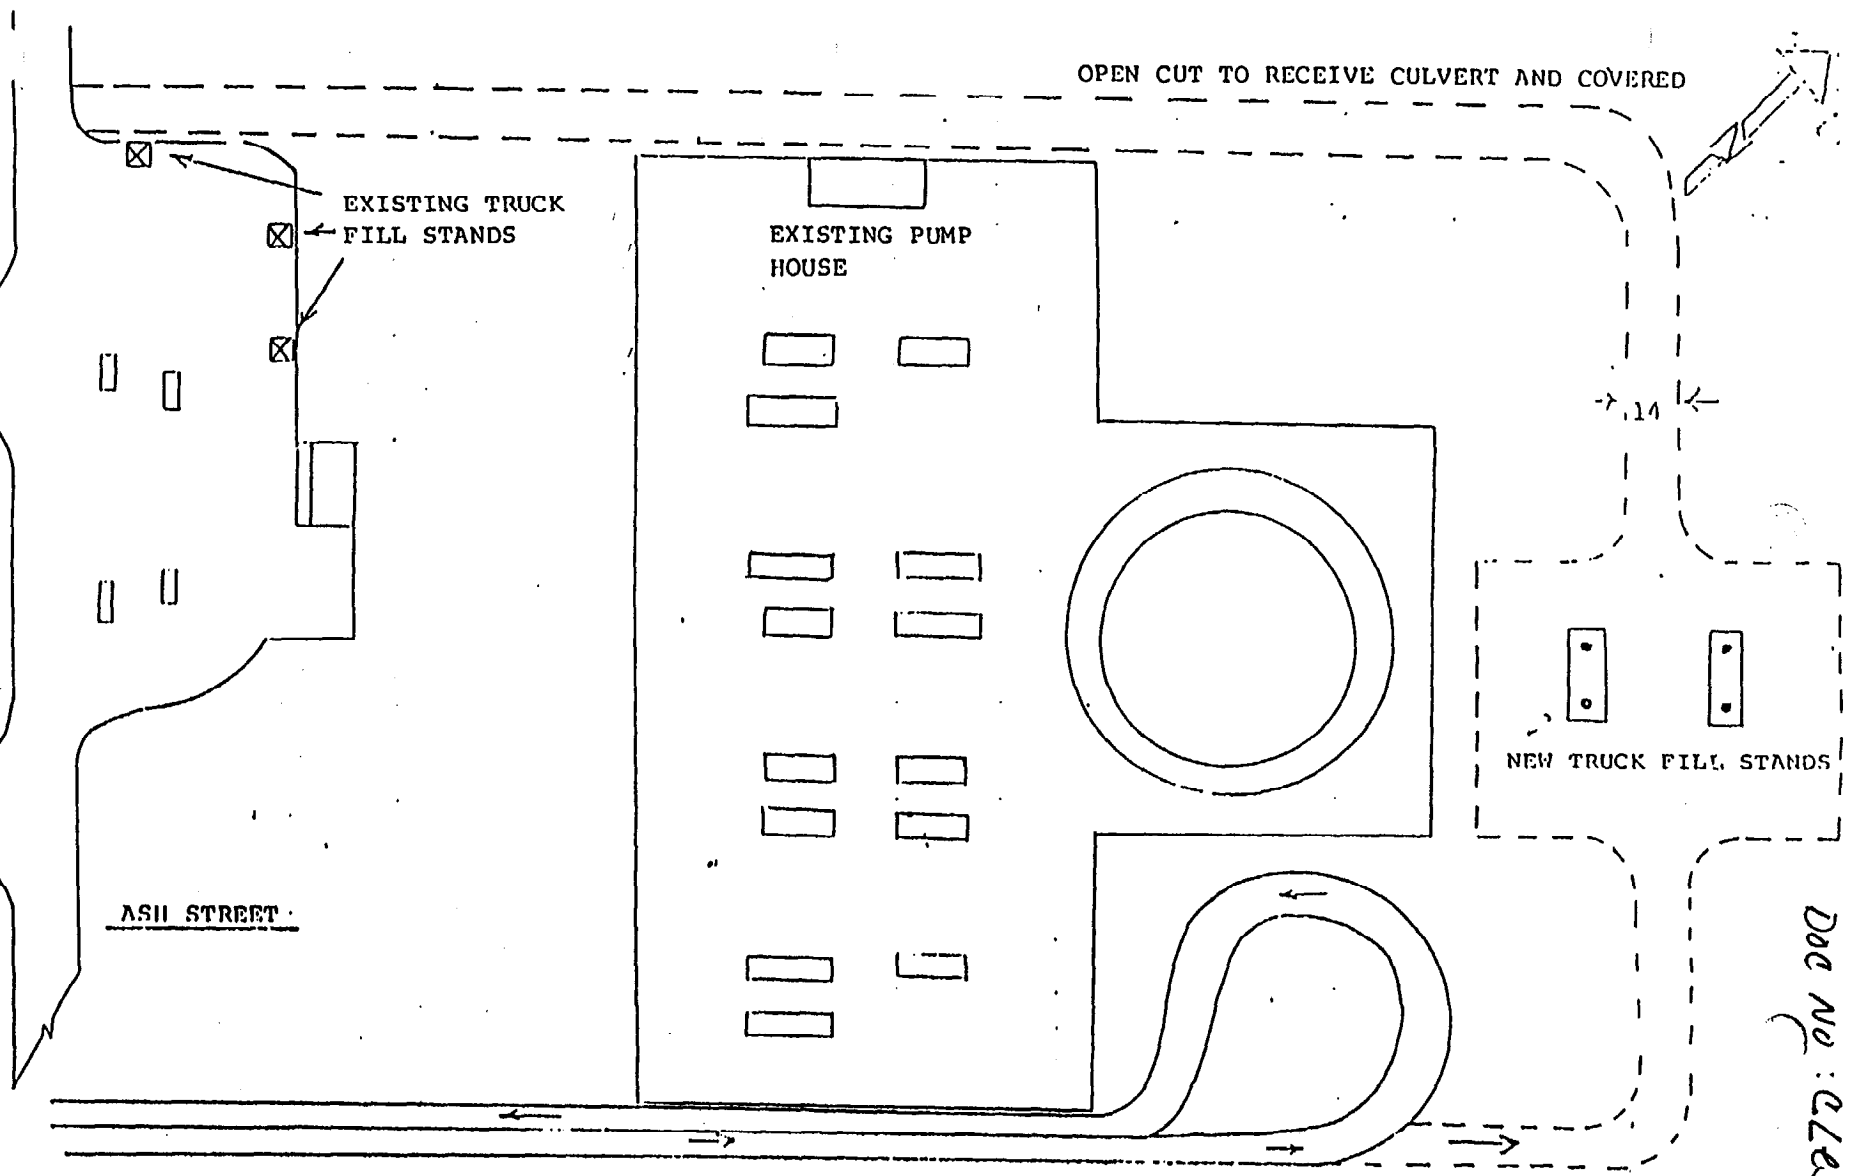
EXISTING TRUCK FILL STANDS

REMARKS: Existing facilities are located too close to Ash Street, creating a safety hazard. Risk Assessment Code IIC3.

OPEN CUT TO RECEIVE CULVERT AND COVERED
