Contractor's Closeout Report
Time Critical Removal Action Plan
Soil Remediation
Operable Unit 11, Site 80
MCB Camp Lejeune
Jacksonville, North Carolina

Contract No. N62470-93-D-3032
Delivery Order 0100

Contractor's Closeout Report

Time Critical Removal Action Plan
Soil Remediation
Operable Unit 11, Site 80
MCB Camp Lejeune
Jacksonville, North Carolina

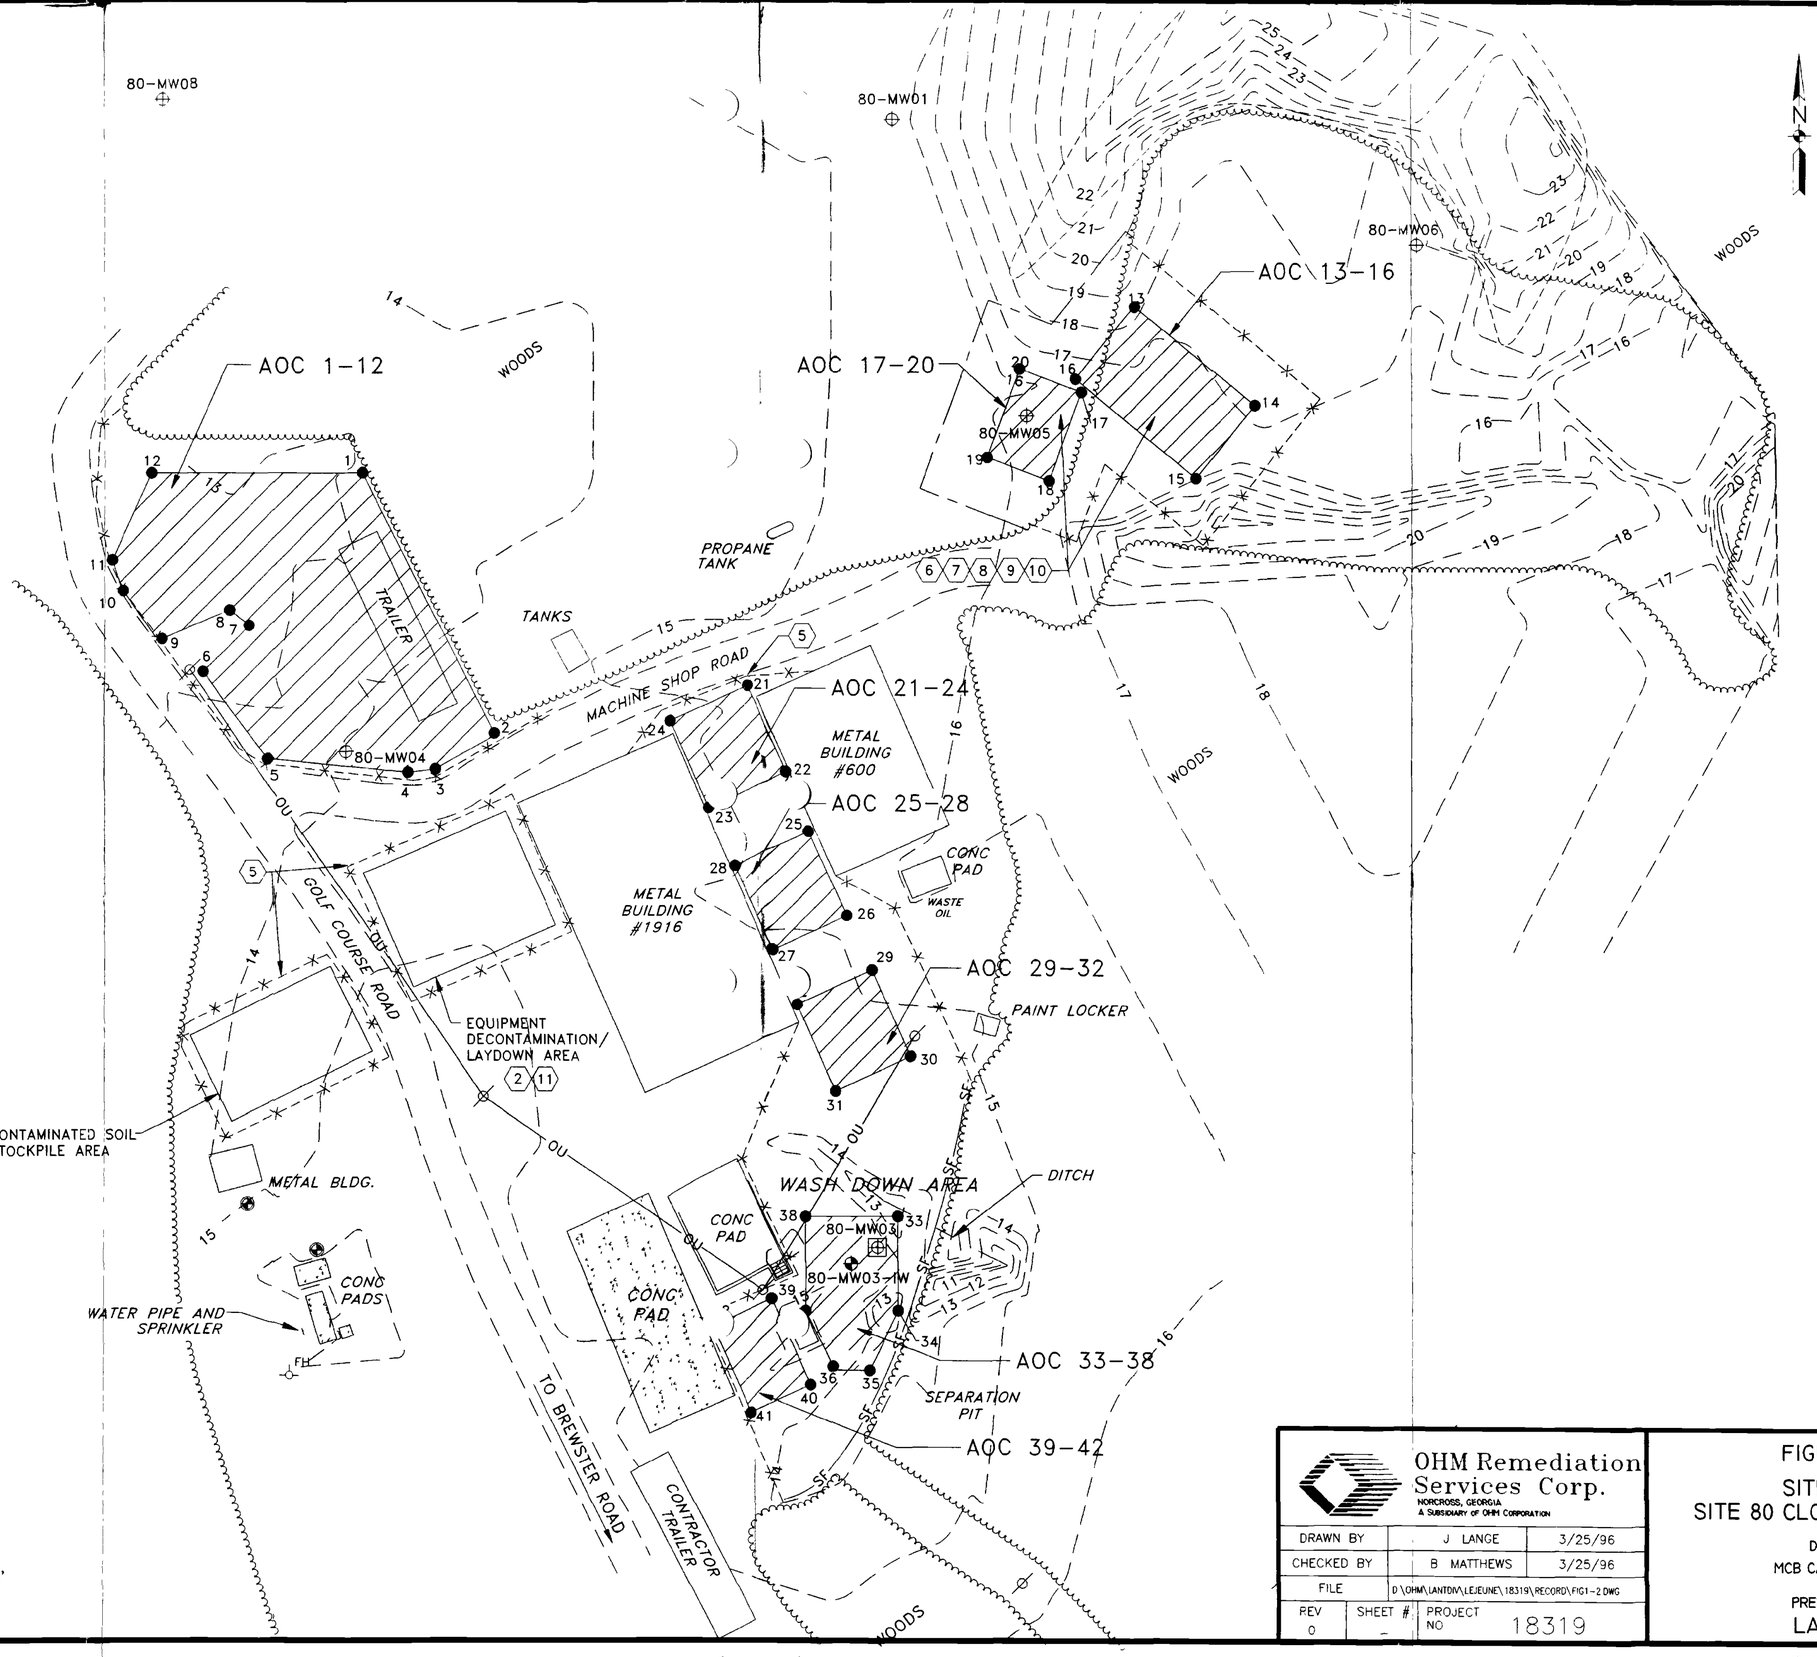
FIGURE 1.2
SITE PLAN
SITE 80 CLOSEOUT REPORT
D.O. #100
MCB CAMP LEJEUNE
PREPARED FOR
LANTDIV

Figure 1.2 presents a site map of the specific area of interest as developed by Baker during the Remedial Investigation. The eight areas of concern (AOC) shown on this figure are those that contain pesticide compounds in concentrations exceeding the Remedial Action Objectives for surface soil discussed in Section 2.0. Site 80 features include a machine shop (Building 1916), a maintenance building (Building 600), and a maintenance wash-down area consisting of a concrete wash pad and sump. The wash pad is used to clean golf course maintenance equipment and the sump is used to collect water and oil run-off generated from the equipment cleaning. Water and oil collected by the sump travels into an oil/water separation pit located southeast of the wash pad (Baker, 1994).

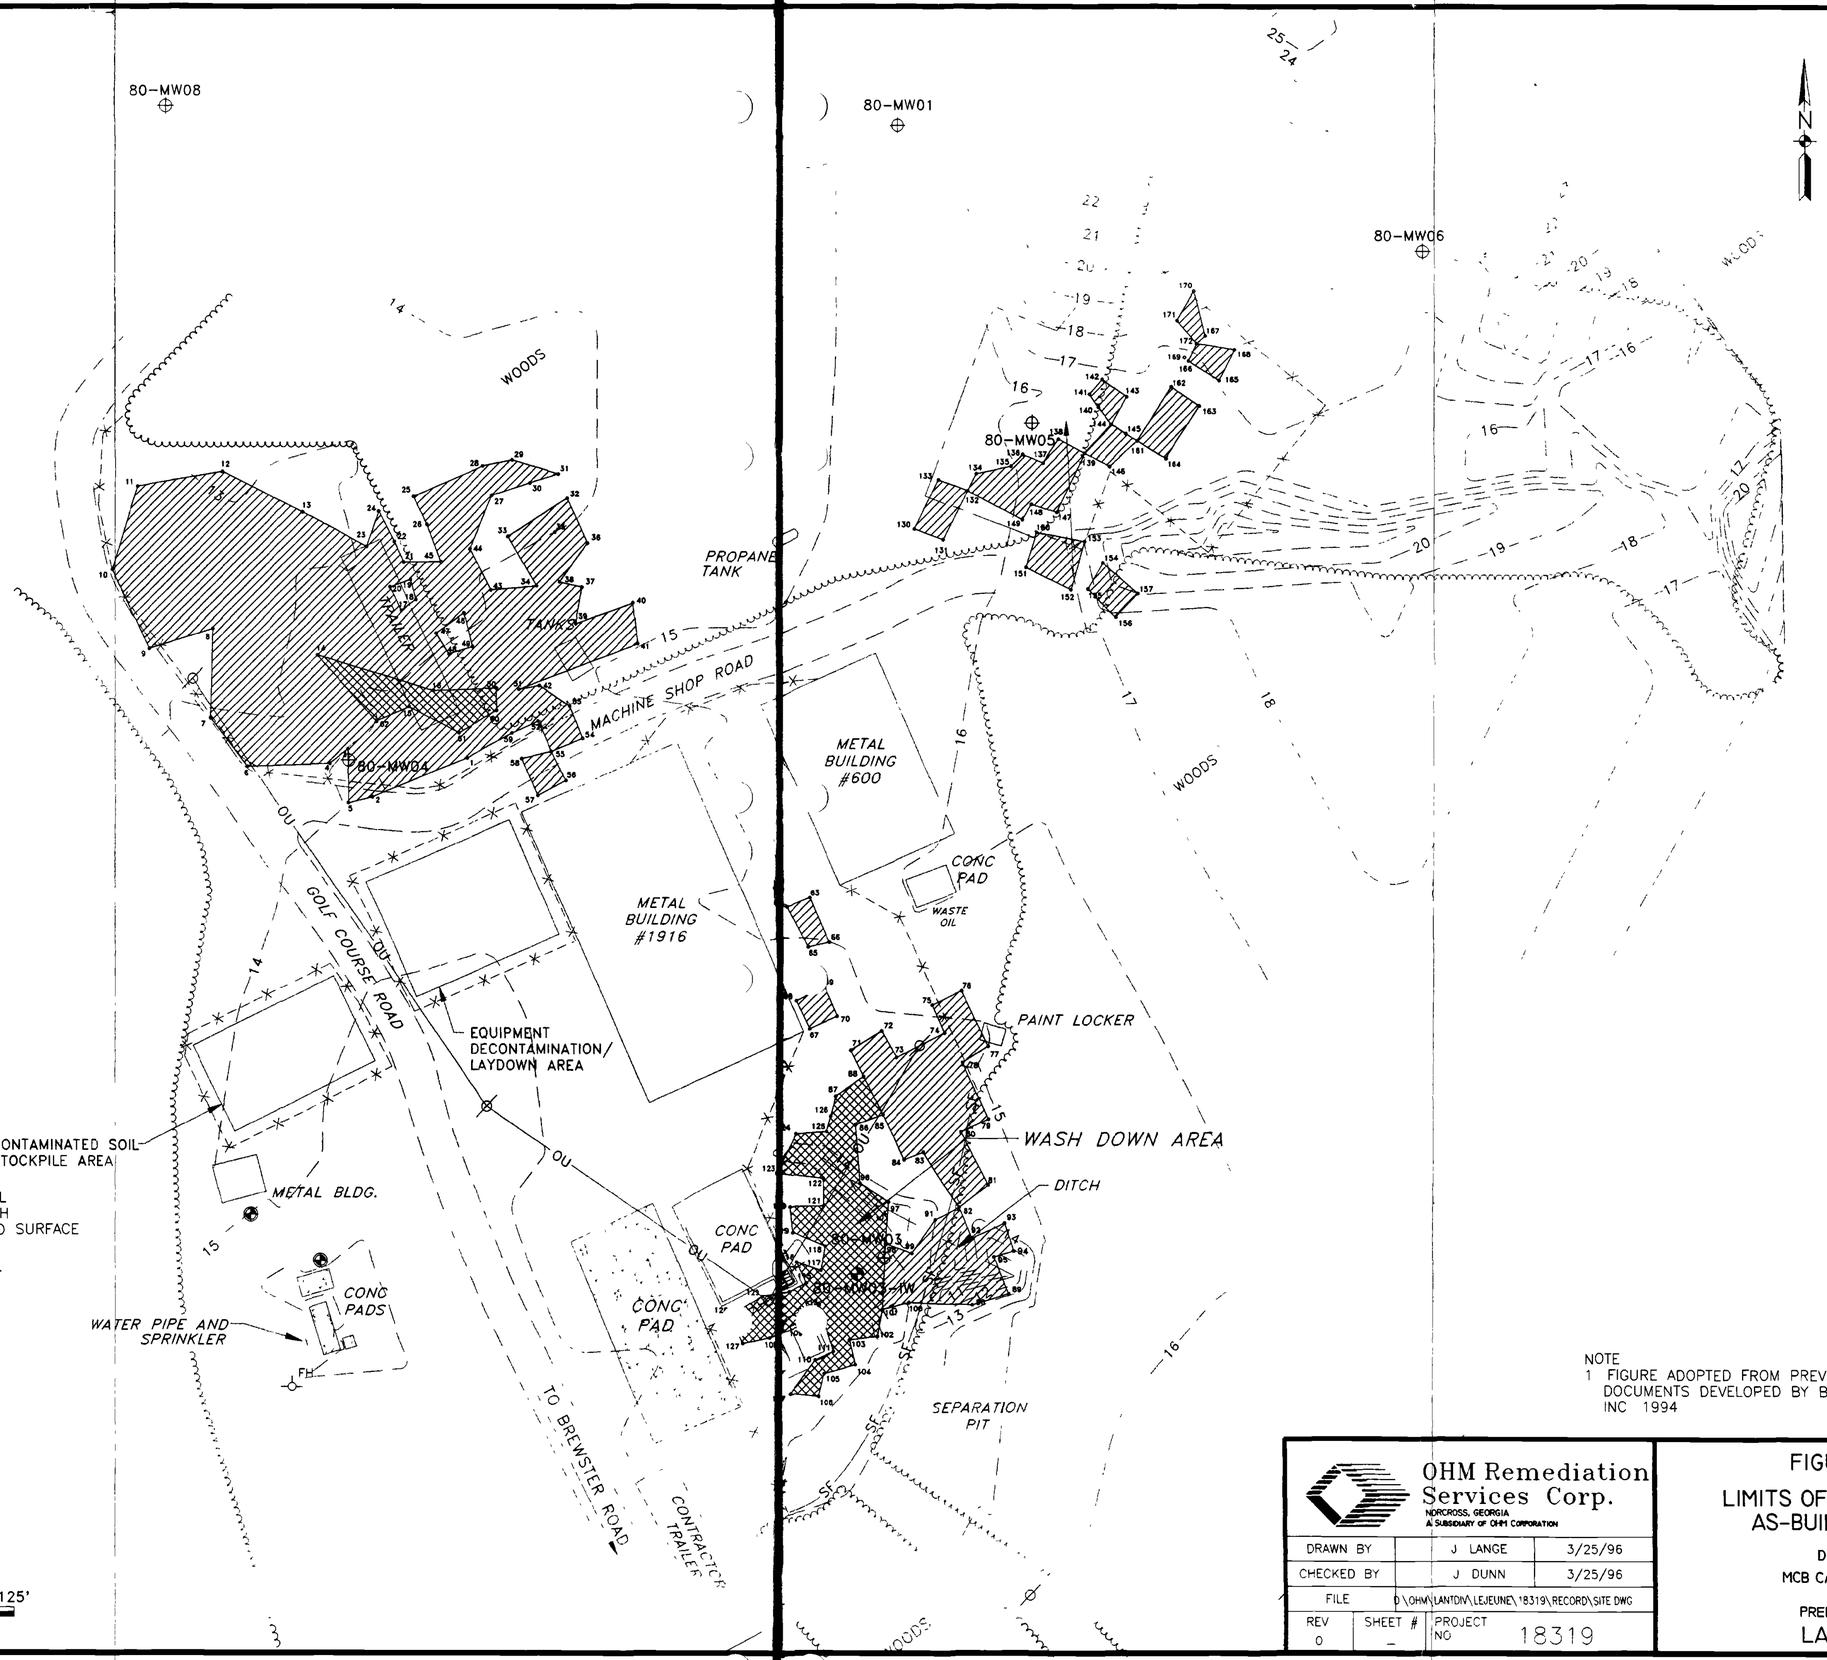
All necessary measures for site drainage, siltation, and erosion control were implemented. All excavations were diked and diversion ditches constructed to minimize contaminant migration from the site. Soil in areas identified during pre-excavation field screening as contaminated was excavated to a depth of approximately 1 foot. The horizontal extent of excavation is shown in Figure 2.1.

Upon completion of field construction activities, excavated areas were backfilled with soils from the Base borrow area. The backfill was compacted utilizing the heavy equipment on-site. Once the areas were brought to the approximate original grade, the area was prepared for planting grass. The disturbed areas were fertilized and seeded. An as-built drawing of the site which depicts the excavation area is presented in Figure 2.1.
